Manhole Inspection Summary

Manhole # S53AA_024MH

Insp Date: **7/16/08 2:19 PM**

Location Address: **3331 mcelderry**

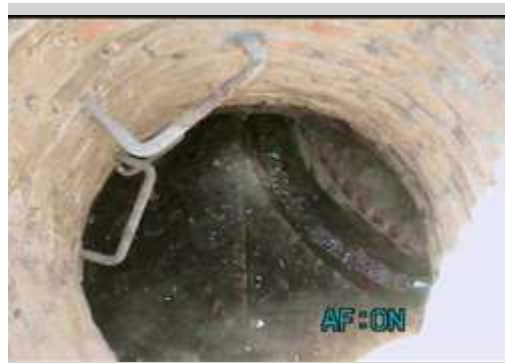
Top View

Steps Count: **3** Missing: **0** ☒ **Corroded**

& steps

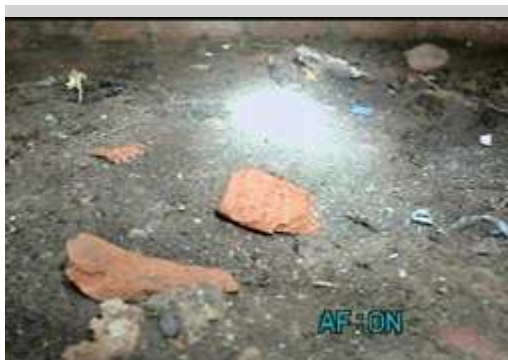
Defect 3

Condition: ☐ Sound ☐ Cracked ☐ Root Intrusion ☐ Deteriorated ☐ Leaks ☒ **Debris**

bench debris

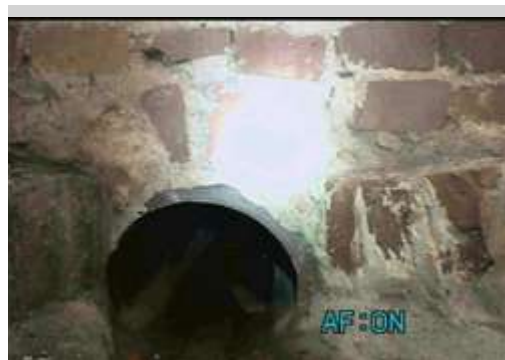
Defect 2

Infiltration: ☐ None ☐ Joint ☐ Cracks ☒ **Mortar** ☐ Roots ☒ **Wall**

infiltration in barrel

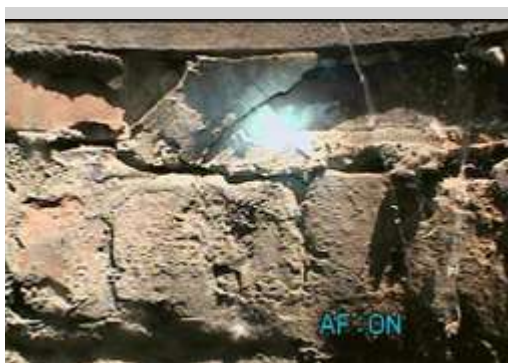
Defect 1

Condition: ☐ Sound ☒ **Cracked** ☐ Root Intrusion ☐ Loose Brick ☐ Deteriorated

Chimney cracked, frame adj

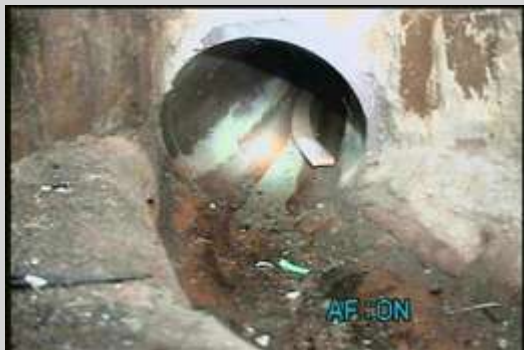
12 O'Clock Outflow

Deposits: ☐ None ☐ Mud ☐ Sludge ☒ Debris ☐ Grease

Silt Depth: 2 (in.) Deposits Extent: Light
